Microwave and Millimeter Wave Nondestructive Evaluation of the Space Shuttle External Tank Insulating Foam

S. Shrestha¹, S. Kharkovsky¹, R. Zoughi¹ and F. Hepburn²

*²NASA George C. Marshall Space Flight Center
Marshall Space Flight Center, AL 35812*

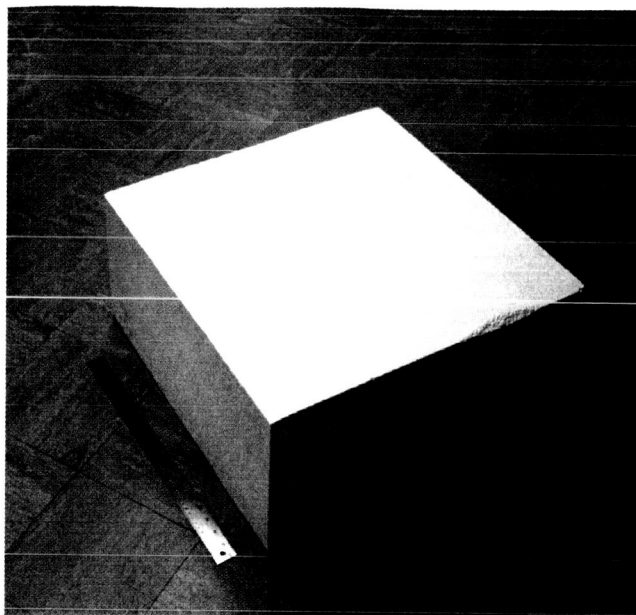
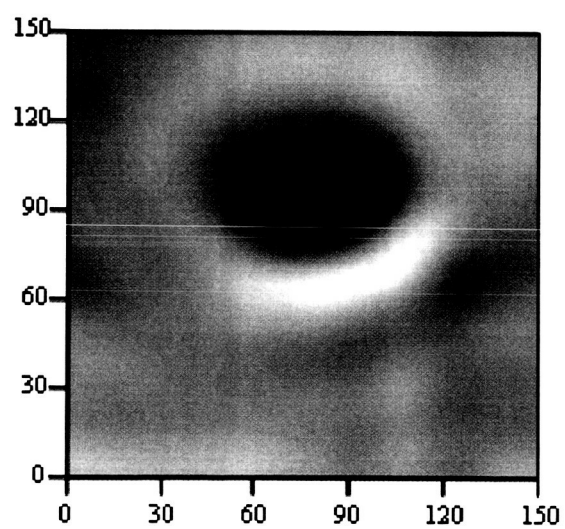
Figure 1

As mentioned earlier, several initial flat panels were used to determine the basic effectiveness of these microwave measurements for inspecting thick insulation foam structures. The foam thickness in these panels varied from 6" to 9" and metallic and rubber washers were embedded inside the foam approximately 2" above the aluminum plate backing. Figure 1a shows the picture of a 9"-thick panel, while Figure 1b shows the X-band image of the embedded washer (dimensions are in mm). The image clearly shows the washer and provides a close estimate of its relative size (considering the distance between the probe and the washer).

- Figure 1: a) Picture of a 9"-thick flat insulating SOFI foam panel, and b) image of an embedded washer at X-band (dimensions in mm).
- Figure 2: Image of a disbond in a flat foam panel with a cork substrate applied to the aluminum backing at K-band.

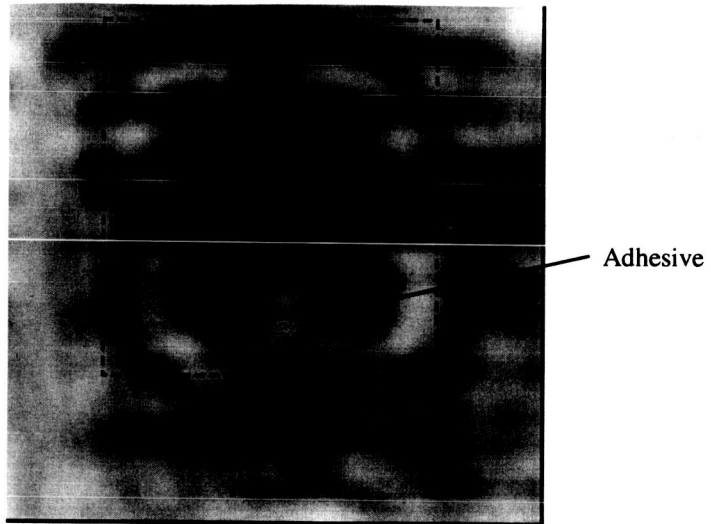
Figure 2

Another 4"-thick flat panel was produced having a thin cork ($\sim 3/8$ " thick) substrate/base applied to the aluminum backing and several disbonds and air voids were embedded on and underneath the cork substrate. All anomalies were detected at K-band and Ka-band. Originally when a disbond was detected in this panel, an interesting "clover-like" pattern was detected in its image. Upon further discussions with those who produced this panel it became evident that the disbond was created by using a thin squared-shaped foam which was secured to the cork substrate using small daps of adhesive at each of its corners. The microwave image of this manufactured disbond at K-band is shown in Figure 2, which clearly shows the disbond and the "clover-like" pattern due to the individual daps of adhesive. The result was significant as it showed the relatively high spatial resolution that may be obtained using these microwave methods. It also indicated the presence of a thin air gap between the cork and the foam section, which is a "real" disbond (the region in the center of the "clover-like" pattern). Another interesting feature was also encountered when inspecting this panel. The microwave images of a set of four voids indicated them to be located at a different place and relative configuration than the schematic of the panel indicated. Once more, upon further discussions it became evident that the actual placing of the voids was not according to the original schematic, but was according to what was indicated by the microwave image.

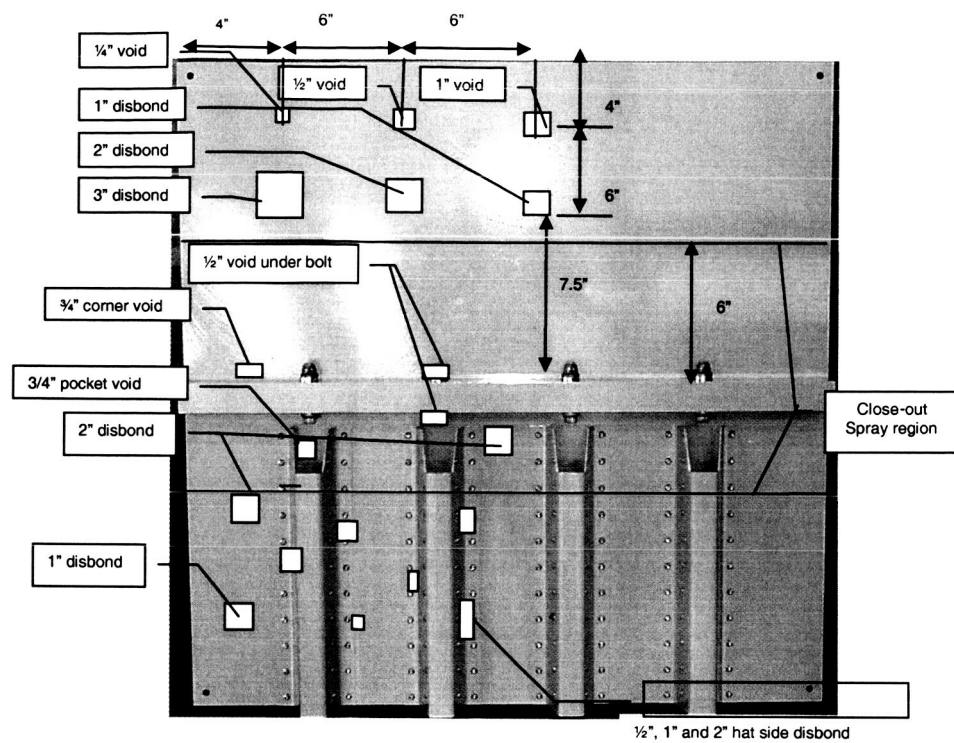
The panels investigated thus far did not include any complicated structural features in their conductor backing, and their foam thicknesses were relatively constant. The next experiment involved a panel containing similar structural features and complexity to that of the external fuel tank. Figure 4 shows a 3' by 3' panel, prior to spraying it with SOFI foam on it, showing various structural components such as four open-top stringers bolted to the metal backing, four bolts joining two vertical metal flanges producing a ridge of about 1" in width, and a relatively large flat area (i.e., approximately the top half of the panel). The approximate locations of various embedded air voids and disbonds are also shown in Figure 4. This panel was then sprayed with SOFI foam in the same manner and geometry as the real respective section of the external fuel tank. Many of the embedded anomalies were detected and their microwave images were produced, with several of these examples discussed here. Figure 5 shows the image of the 3/4" corner void (to the left of the left most bolt) at K-band. The image clearly shows the void and its boundaries in the presence of the bolt. This image was minimally processed to remove the influence of changing SOFI foam thickness in this region. Figure 6a shows the 2" disbond in between the second and the third stringers, at K-band. The presence of the row of bolt heads on both sides of this anomaly is also shown in this image. To better demonstrate this, Figure 6b shows the image of a section of a stringer (devoid of anomalies) showing the rows of bolts on either sides of it.

- Figure 3: a) Schematic of the panel with 40 voids, and b) augmented image of the panel at V-band.
- Figure 4: Picture of a 3' by 3' panel prior to the application of SOFI foam layer showing the location of several embedded anomalies.

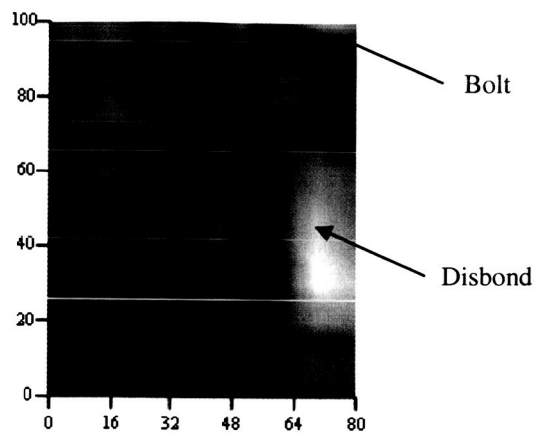
Figure 5

- Figure 5: Image of the 3/4" corner void in presence of a bolt.
- Figure 6: a) Image of a 2" squared disbond in between the stringer regions, and b) image of the region between two stringers with no anomaly showing the row of bolt heads.

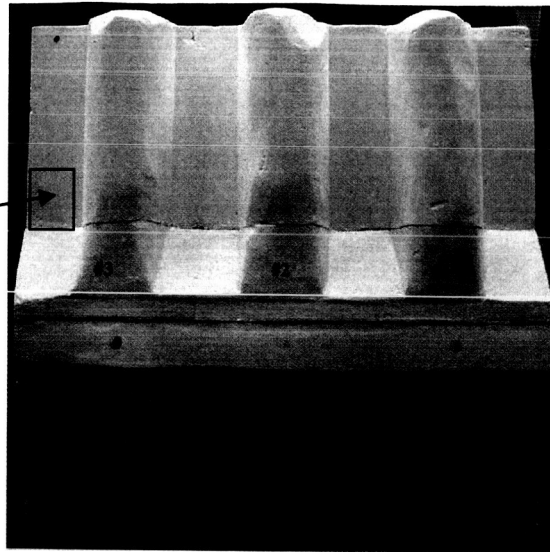
Subsequent to demonstrating the capability of these microwave methods for detecting and evaluating anomalies in various locations within simple and thick SOFI foam panels and more typical and structurally complicated panels, a blind test was conducted. This test involved inspecting a section of a panel, similar in geometry to that shown in Figure 4, possessing three stringers. Additionally, several anomalies had been embedded in this panel. The locations of these anomalies were not revealed to the investigating team (e.g., a blind panel). The metal backing also included several equally spaced drilled holes around its edges. These holes are strong scatterers, however they are not anomalies for the purpose of this investigation. Figure 7 shows a picture of this panel with the stringers numbered as shown.

- Figure 7: Picture of the 2' by 2' "blind" panel.
- Figure 8: a) Patched image of the entire "blind" panel at K-band at horizontal polarization, and b) at vertical polarization.

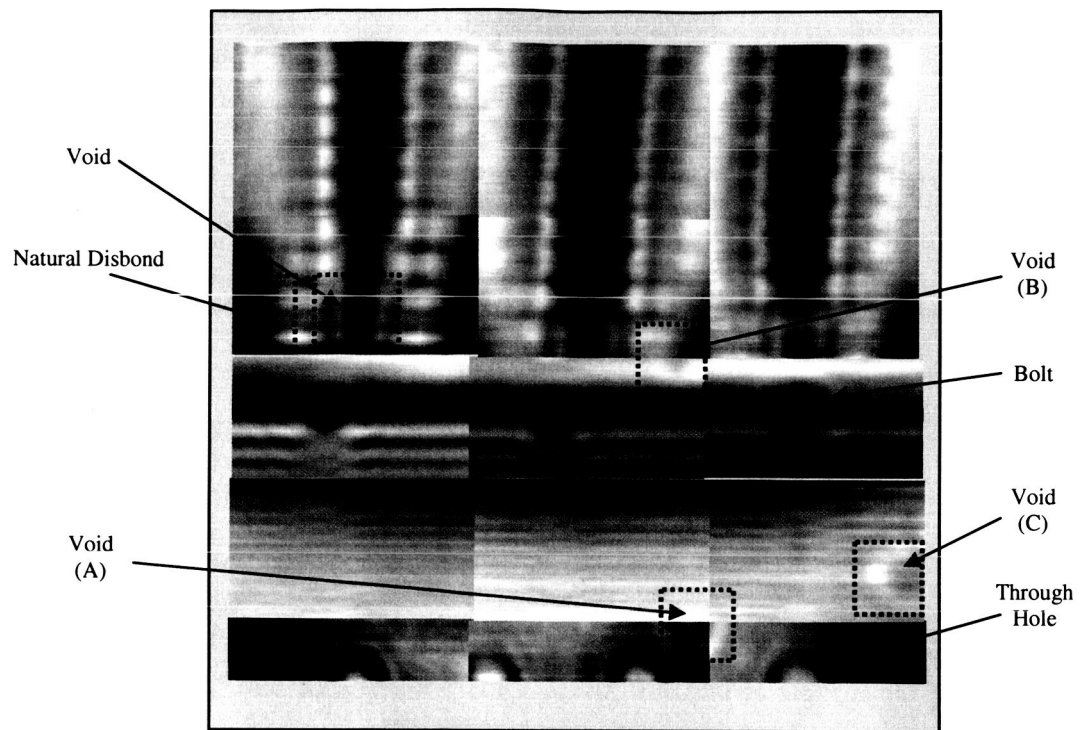
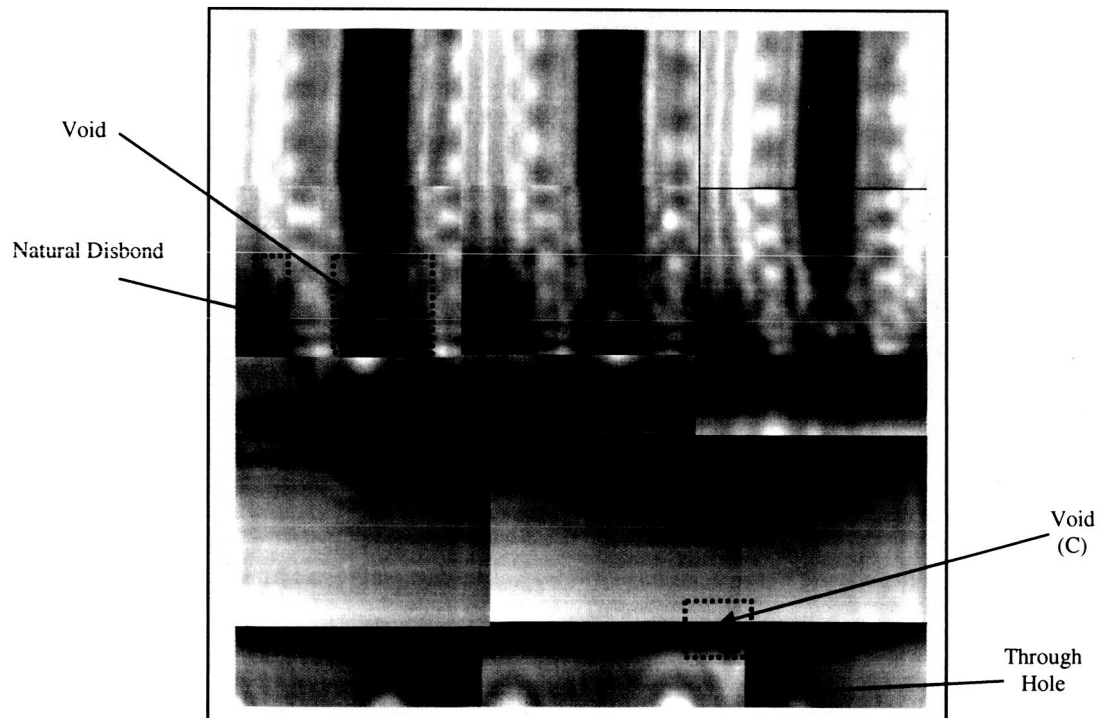
Figure 8

It must be noted that structural features, whose primary axes are parallel to the incident wave polarization vector, are expected to be more clearly detected. This fact is evident in Figure 8a when considering the image from the stringers and the bolt heads. Both of these features have axes parallel to the incident electric field polarization vector and hence are clearly detected. The rings around the bolt heads are due to edge scattering from the bolts.

Both images clearly show the presence of the through holes around the bottom edge of the panel. The panel also possessed a natural and visible disbond at the bottom of the ramp adjacent to stringer #3. Figures 8a and 8b clearly show the presence of this disbond (when compared to the

same region near stringer #1). Figure 8a also shows three distinct indications of potential voids (labeled A-C). It is important to note that two of these potential voids are near strong scattering objects, namely a through hole and a bolt head, respectively. Nevertheless, their presence is clearly indicated in this image. To better illustrate the presence of potential void A, Figure 9 shows the region immediately surrounding this anomaly using parallel polarization. One can clearly see the indication associated with the presence of this potential void.

Subsequently, the foam was destructively inspected for the presence of the potential anomalies. The “potential” voids (A-C) were verified to exist and be located where the microwave images indicated them to be. However, something interesting was discovered when inspecting the stringer opening regions. It turns out that two similar voids were embedded in the opening regions of stringers #1 and #2. All images from these two regions show extreme similarity corroborating the fact that these regions were indeed similar. However, an unintentional void was discovered in the stringer #3 opening region. All images produced from this region showed significant difference between it and the same regions in stringers #1 and #2. This finding is

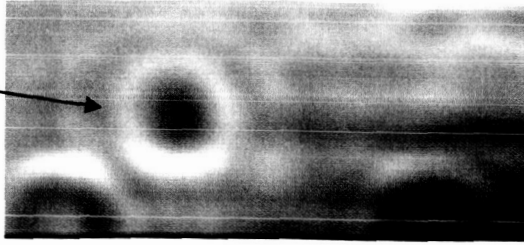
Figure 9

- Figure 9: Localized image of Void (A) in the presence of two through holes.
- Figure 10: Augmented images of the three stringer openings.

Void
(A)

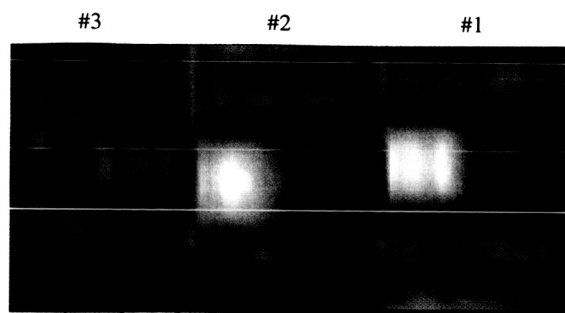
Figure 10

Stringer #3 opening region is clearly different than the same region for the other two stringers. Initially it was determined that there must be a void in the opening region of stringer #3. This decision was partially due to the fact that the other two stringer opening regions produced very similar images. To increase the level of confidence in associating a potential embedded void in this region, the image of the three stringer opening were also produced at Ka-band. Figures 10 shows the augmented images of these three regions, indicating a clear difference in the image obtained from stringer #3 opening region than the other two stringers. Consequently, the investigating team decided that stringer #3 opening region must have a potential void in it. It is very important to note that there are many stringers around the real external fuel tank. Consequently, images from many of these areas which can be compared and a decision about the presence of potential voids can be made with much higher levels of confidence and certainty on the real external tank. In this investigation we only had three such areas available and the decision to indicate a potential void in stringer #3 opening region was made based on the obtained images from these limited number of stringers.
